Manhole Inspection Summary

Manhole # S35Q__019MH

Location Address: **1001 olive st**

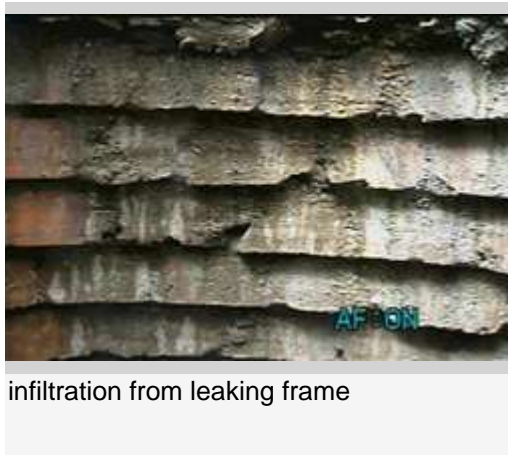
Defect 5

☒ **Leaks**

infiltration from leaking frame

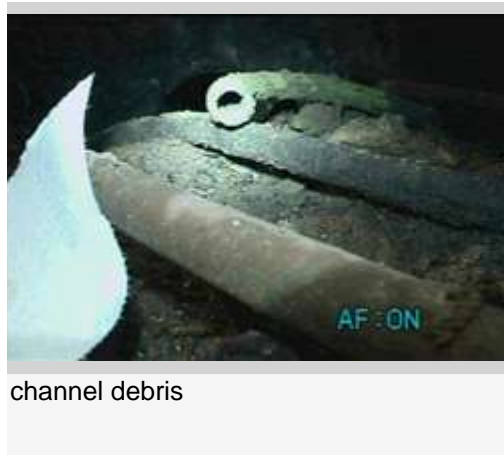
Defect 4

☒ **Debris**

channel debris

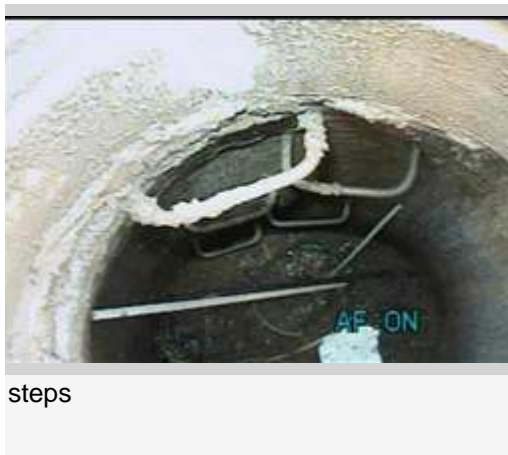
Defect 3

☒ **Corroded**

steps

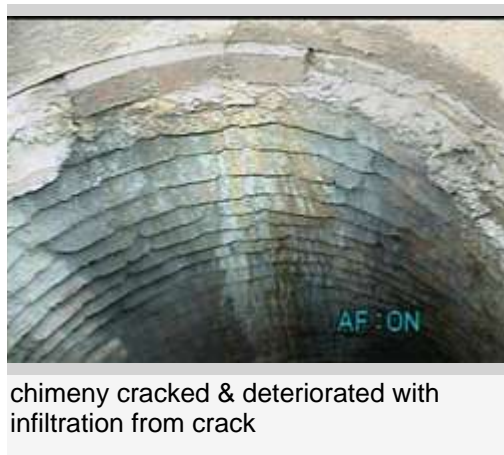
Defect 2

☒ **Cracked**

☒ **Loose Brick**

☒ **Cracks**

chimney cracked & deteriorated with infiltration from crack

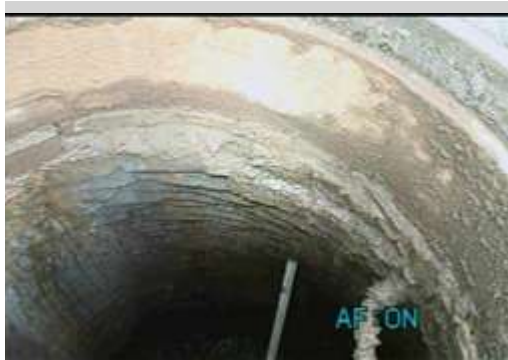
Defect 1

Offset: **1** (in.)

offset

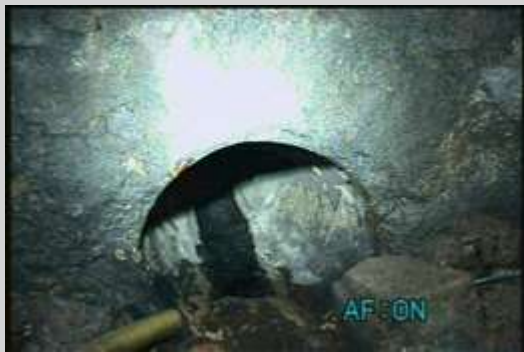
12 O'Clock Outflow

8 in. Circular Gravity Sewer
Pipe Out @ 12 O'Clock

Invert Depth: **8.13** (ft.) Flow Characteristics: **Slow**

Infiltration: **None** Pipe Seal Cond: **Unknown**
